**PATRICK W. STUCKEY ARCHITECTS**

Re: Initial Overview of Historic Museum located at 116 North  
4<sup>th</sup> Street, New Castle, Colorado

**MIKE THELE, P.E.**

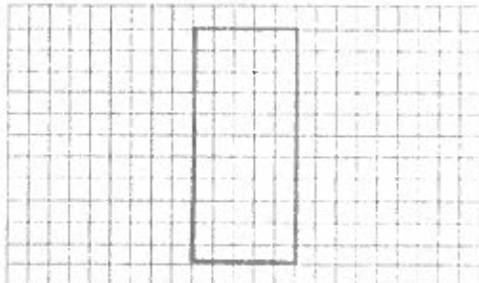
<b>PLAN SHAPE:</b>

**CONSTRUCTION HISTORY (DESCRIPTION, NAMES, DATES, ETC., RELATING TO MAJOR ALTERATIONS TO ORIGINAL STRUCTURE):**  
 Roof shape of main part of building was originally flat; gable added later. The cinderblock rear addition was added as a furnace room in the 1960s. Stucco was added to the exterior to preserve the locally made brick.

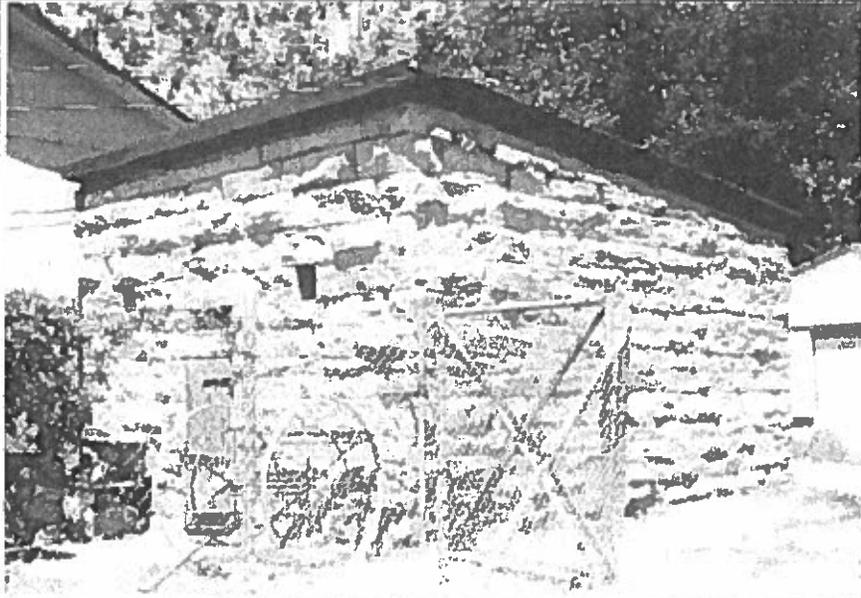
DATE OF CONSTRUCTION: ESTIMATE: 1895 ACTUAL: SOURCE: Sanborn Maps, 1893-99		
		USE: PRESENT: Museum Exhibit  HISTORIC: Jail		
		CONDITION: EXCELLENT X GOOD FAIR DETERIORATING		
		EXTENT OF ALTERATIONS: X MINOR MODERATE MAJOR DESCRIBE: Roof replaced.		
		CONTINUED YES X NO		
STYLE: Vernacular Masonry		STORIES: 1	ORIGINAL SITE X MOVED DATE(S) OF MOVE:

MATERIALS: Stone		SQ. FOOTAGE:	NATIONAL REGISTER ELIGIBILITY	
ARCHITECTURAL DESCRIPTION: One-story jail building composed of roughly quarried coursed stone; stone foundation. Walls about 2' thick. Shed roof with concrete below roofline; rolled roofing and overhanging eaves. Center door composed of vertical boards with iron hinges and metal lock bar. Three small vent openings on facade. Interior divided into two cells to recreate original appearance.		INDIVIDUAL: X YES NO		
		CONTRIBUTING TO DISTRICT: YES NO		
		LULAL LANDMARK DESIGNATION. NO NAME: DATE:		
		ASSOCIATED BUILDINGS? X YES NO TYPE: Town Hall		
ADDITIONAL PAGES: YES X NO		IF INVENTORIED, LIST ID NOS.: SGF

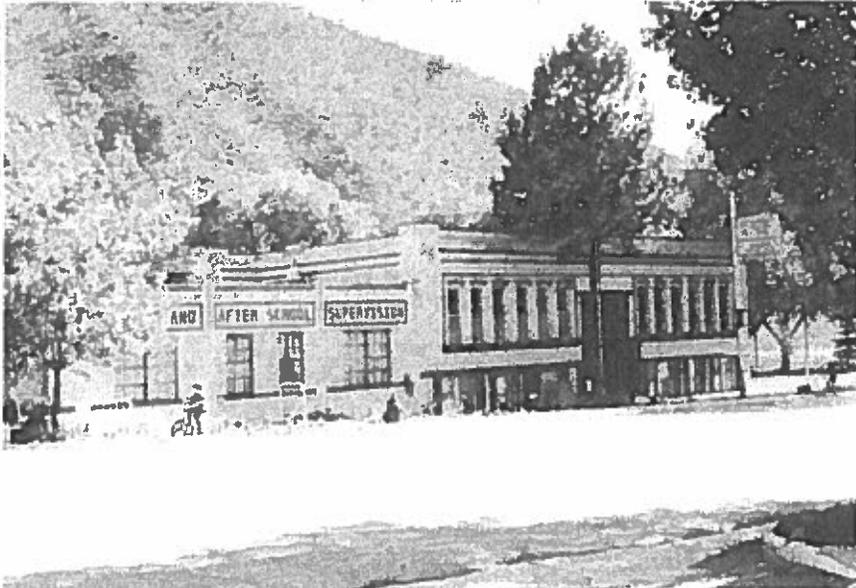
USE: PRESENT: Childcare Center HISTORIC: School
				CONDITION: EXCELLENT X GOOD FAIR DETERIORATING
				EXTENT OF ALTERATIONS: MINOR X MODERATE MAJOR DESCRIBE: Painted brick and stone; addition on east (1937); stairs and deck on west; some basement windows boarded up. Originally had pediment on facade, removed many years ago. Entrance added to facade by 1920.

CONTINUED YES X NO
STYLE: Vernacular Masonry	STORIES: 1	ORIGINAL SITE X MOVED DATE(S) OF MOVE:		
MATERIALS: Brick, Stone, Adobe (addition)	SQ. FOOTAGE: 18,565	NATIONAL REGISTER ELIGIBILITY INDIVIDUAL: YES X NO CONTRIBUTING TO DISTRICT: YES NO		
ARCHITECTURAL DESCRIPTION: One-story brick school building with raised basement level; one-story addition on east. Flat roof with cornice of decorative brickwork. Piers at each corner of building project above roofline. Walls composed of painted brick with decorative panels on side walls; painted stone foundation and basement level. Central, recessed entrance with two sets of double doors topped by large four-light transoms. Double door on west with arched, divided transom and decorative brick lintel. Series of six tall, narrow, double-hung windows with segmental arched lintels and shared sill course flank entrance. Double-hung windows, paired and single, in basement level. Addition on east is composed of adobe brick, one-story, flat roofed, with large multi-light windows and stepped cornice with with Art Deco speed lines.				LULAL LANDMARK DESIGNATION. NO NAME: DATE:
